# Property Management Report

26161 Del Rey #D

Move Out

2018-07-31

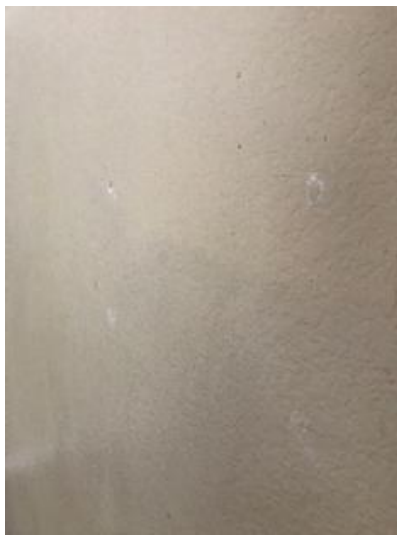
| Living Room | CONDITION | ACTION | COMMENTS |
|---|---|---|---|
| Wall/Ceiling | - S - - | None | Noticeable drywall repair. Is passable |

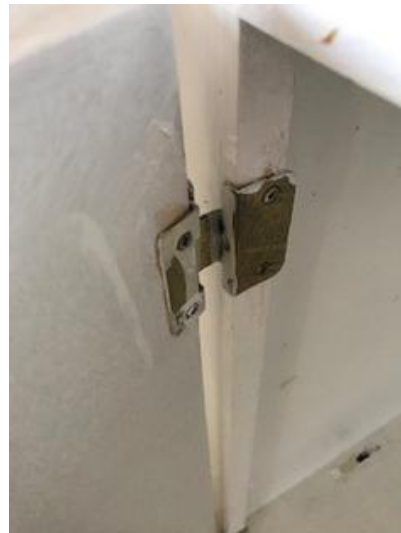
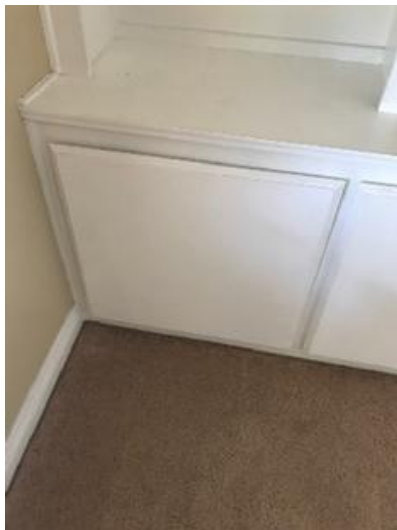
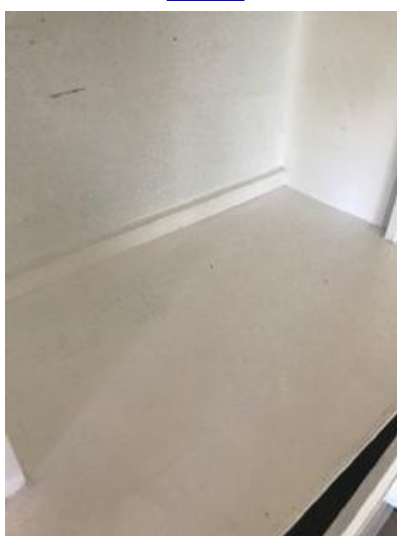
| Dining Room | CONDITION | ACTION | COMMENTS |
|---|---|---|---|
| Other | - S - - | None | Relighted cabinet hinge, and leftmost cabinet has an issue closing flush |

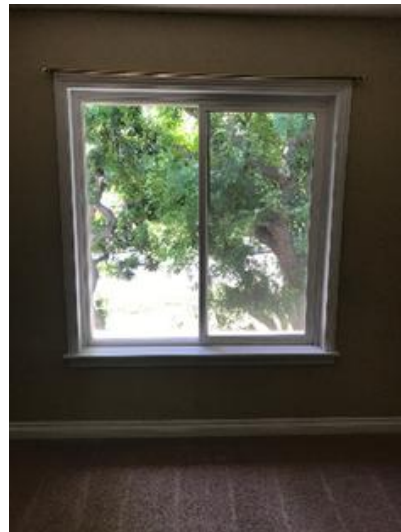
| Bedroom 1 | CONDITION | ACTION | COMMENTS |
|---|---|---|---|
| Window/Lock/Screen | - - ! - | Maintenance Required | Screen needs to be refitted / reinstalled |

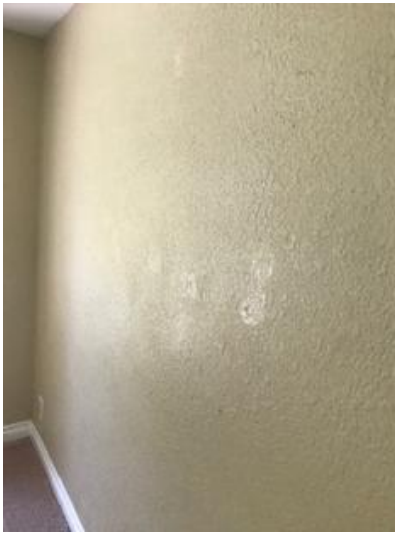
| Bedroom 1 | CONDITION | ACTION | COMMENTS |
|---|---|---|---|
| Wall/Ceiling | - - - - | Other - See Comments | Noticeable touch up paint, but not a major concern |

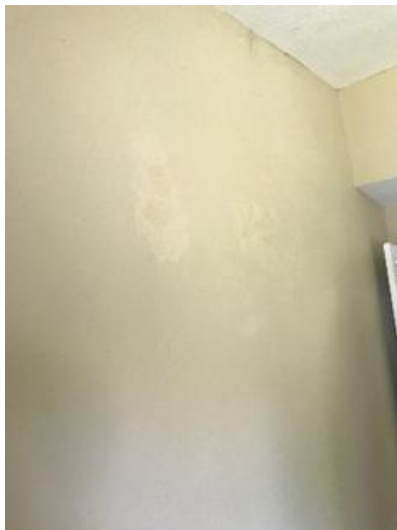
| Bedroom 2 | CONDITION | ACTION | COMMENTS |
|---|---|---|---|
| Wall/Ceiling | - - - - | Other - See Comments | Noticeable touch up paint. Not a major concern |

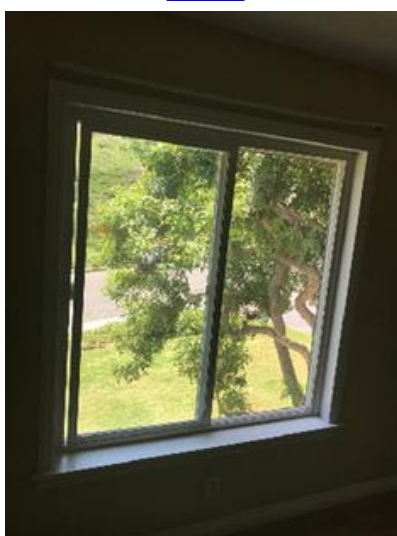
| Bedroom 2 | CONDITION | ACTION | COMMENTS |
|---|---|---|---|
| Window/Lock/Screen | - - ! - | Maintenance Required | Screen needs to be refitted/reinstalled |
