# Property Management Report

26161 Del Rey #D

Move Out

2018-07-31

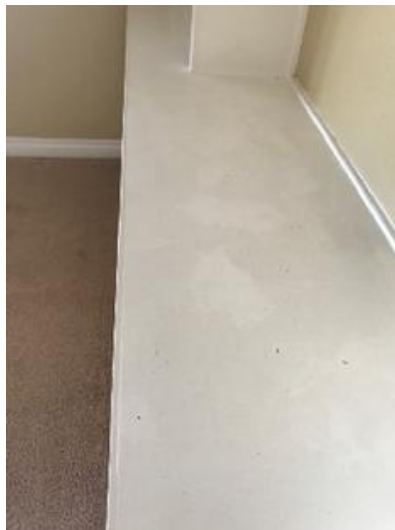
| Dining Room | CONDITION | ACTION | COMMENTS |
|---|---|---|---|
| Other | - S - - | None | Relighted cabinet hinge, and leftmost cabinet has an issue closing flush |

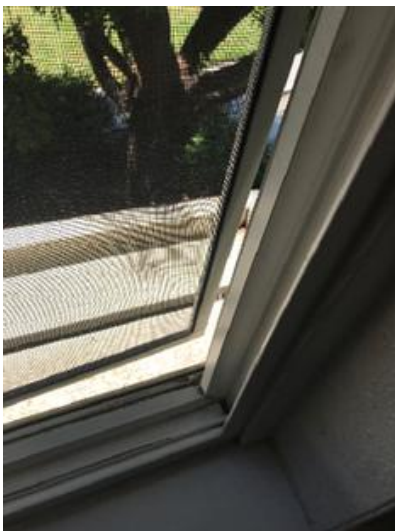
| Bedroom 1 | CONDITION | ACTION | COMMENTS |
|---|---|---|---|
| Window/Lock/Screen | - - ! - | Maintenance Required | Screen needs to be refitted / reinstalled |

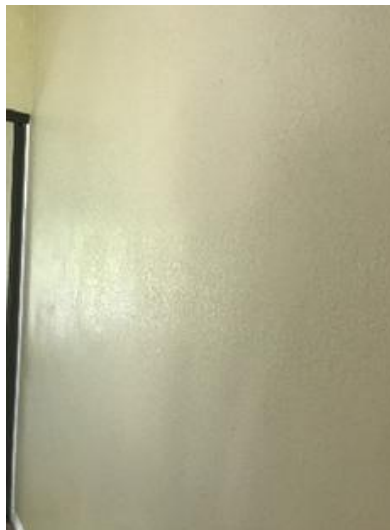
| Bedroom 2 | CONDITION | ACTION | COMMENTS |
|---|---|---|---|
| Wall/Ceiling | - - - - | Other - See Comments | Noticeable touch up paint. Not a major concern |

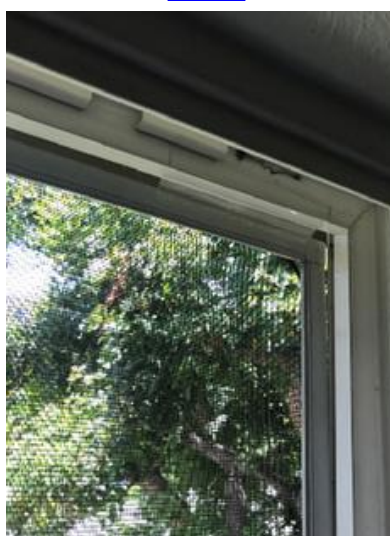
| Bedroom 2 | CONDITION | ACTION | COMMENTS |
|---|---|---|---|
| Window/Lock/Screen | - - ! - | Maintenance Required | Screen needs to be refitted/reinstalled |
